task III
performance testing
of solar collectors

subtask b
Development of test procedures for
reliability and durability

**FAILURE MODES
OF SOLAR COLLECTORS**

august 1981

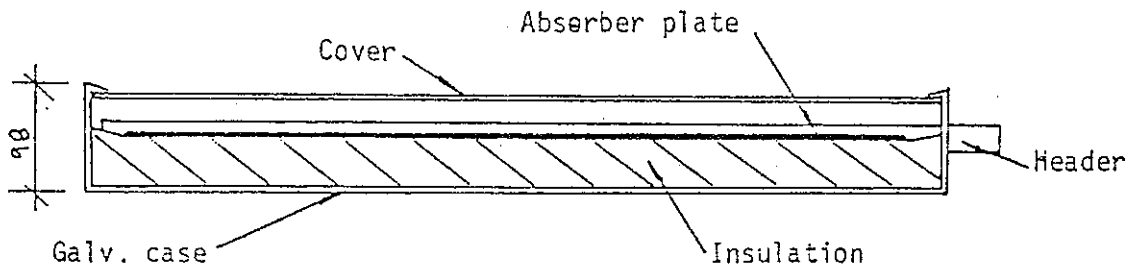
COLLECTOR CROSS SECTION

- Collector A: 1-1-2 Condensation
 1-2-1 Slight sag in cover
 1-7-3(L) Dirt on cover
 2-1-1(L) Seal damaged
 8-3-5 Pipework, insulation missing

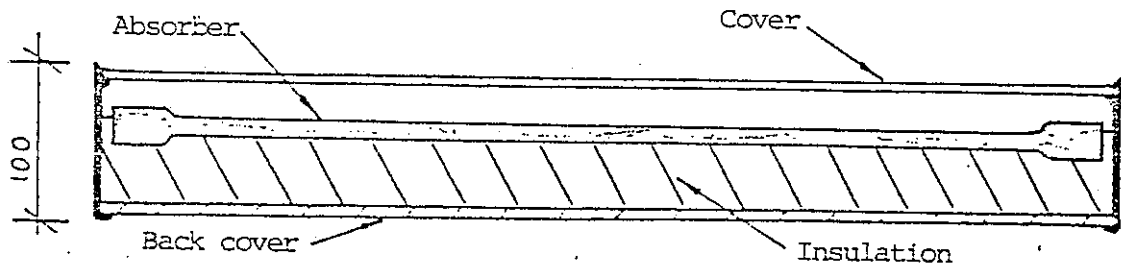
COLLECTOR CROSS SECTION

- Collector B: 5-1-2(L) Galvanic corrosion of enclosure
 5-1-2 Moisture in collector
 1-7-4 Glass breakage of one panel
 2-1-2 Cover glass seal not water tight
 3-2-2 Absorber corroded

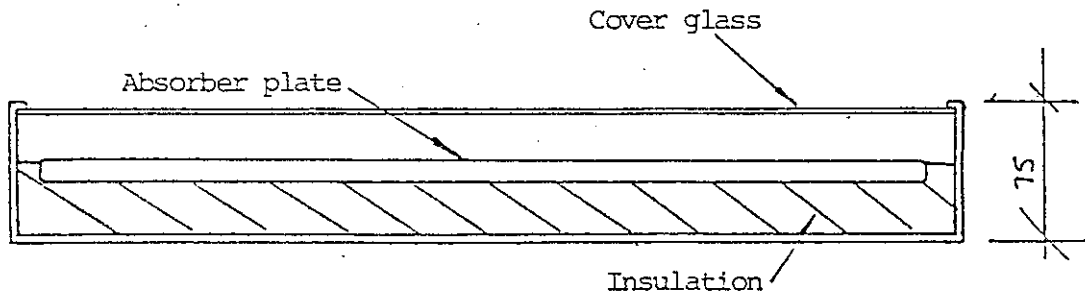
CROSS SECTION THROUGH SOLAR COLLECTOR

<u>Collector C:</u> 1-1-1	Glass breakage
3-2-2 (L)	Absorber coating discoloured
5-1-2 (L)	Steel supports and screws corroded
8-4-5 (L)	Connections of pipes degraded
8-4-2	Manifold insulation broken in places

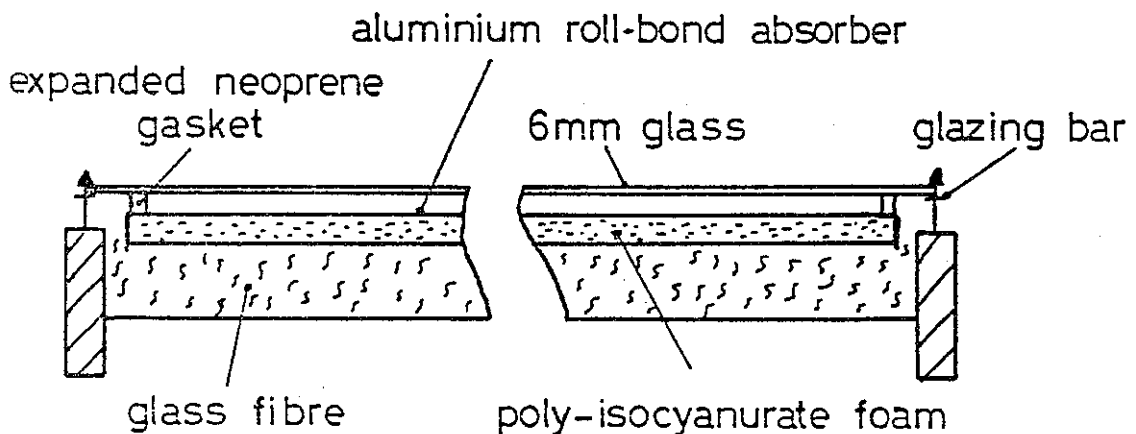
<u>Collector Z:</u> 1-1-2	Condensation
1-1-1	Glass cracked
1-7-3 (L)	Cover dirty
2-1-1 (L)	Neoprene gasket shrunk, sealant rope rotten
3-1-2 (L)	Absorber coating dirty and corroded
7-1-2 (L)	Flashing in poor condition

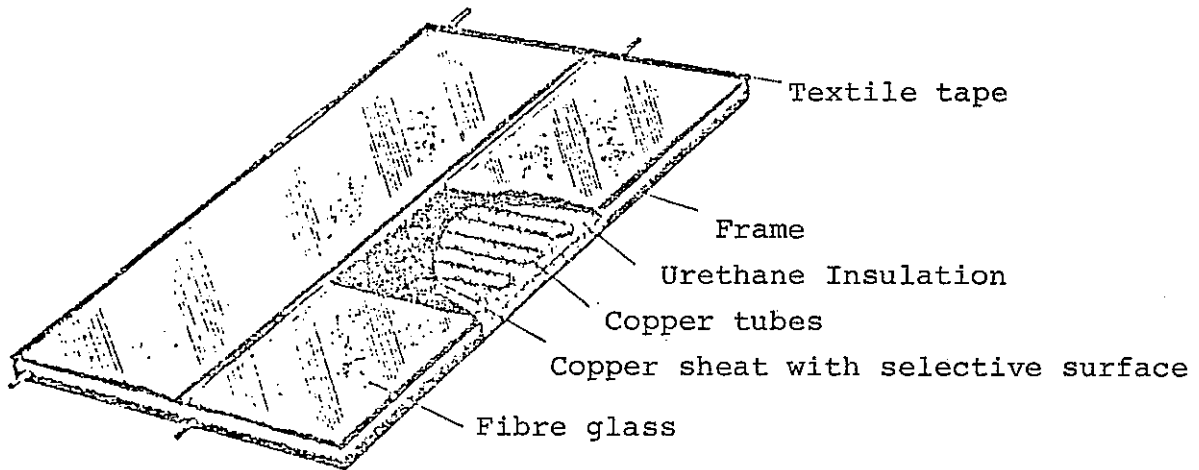
<u>Collector D:</u>	1-1-1	Yellow outgassing
	1-1-2	Condensation
	1-2-3 (L)	Cover ageing
	2-1-2 (L)	Textile tape destroyed
	3-1-3 (L)	Dust on absorber
	3-3-2 (L)	Corrosion at absorber edges

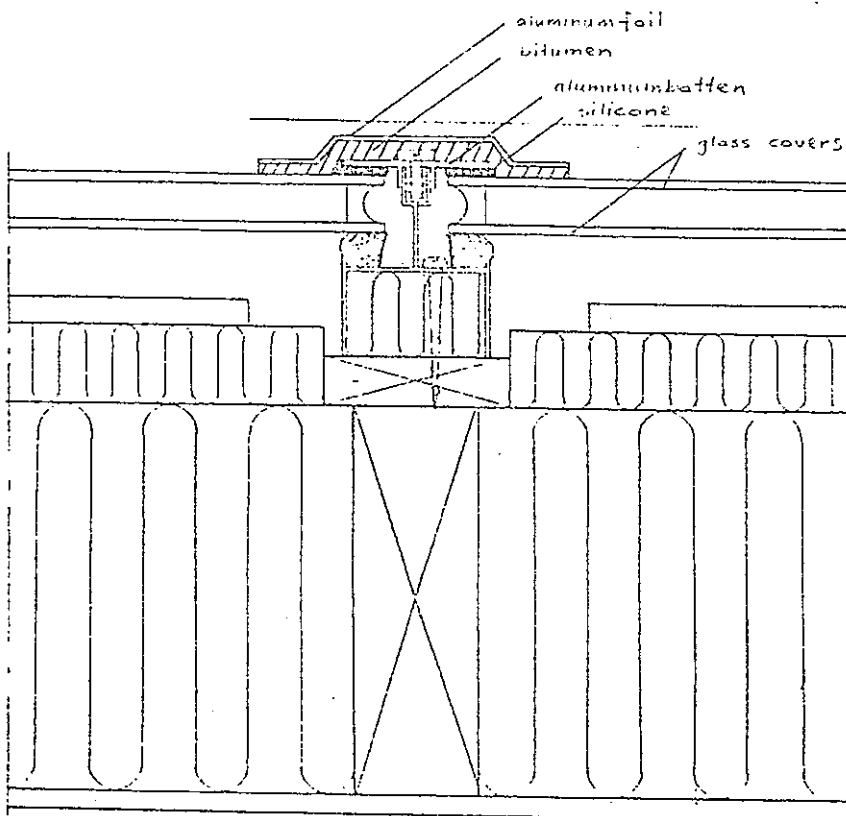
- Collector F: 1-7-3 (L) Dust on covers
 3-1-2 (L) Moisture in collector
 white rust on absorbers
 3-1-1 Absorbers bulged and
 almost touched cover

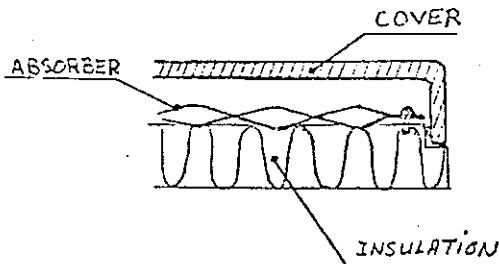
- Collector G: 3-1-2 (L) Absorber corroded in places
 3-3-5 Primer on absorber visible
 5-2-2 AL battens unstuck
 5-1-2 Traces of water on absorber

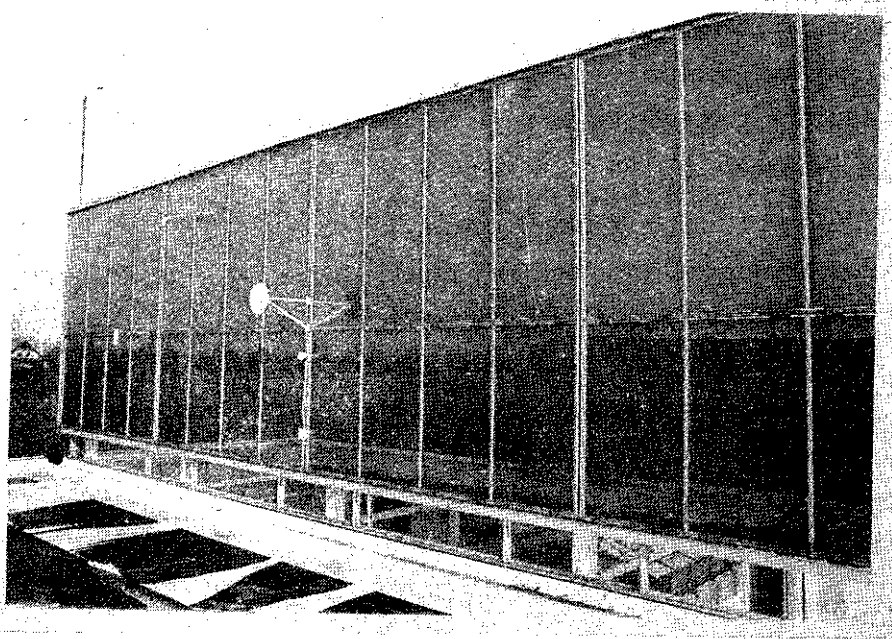
Fig. 1. Cracked glass and some condensate between panes. Reflector on roof, in front of picture, is broken.

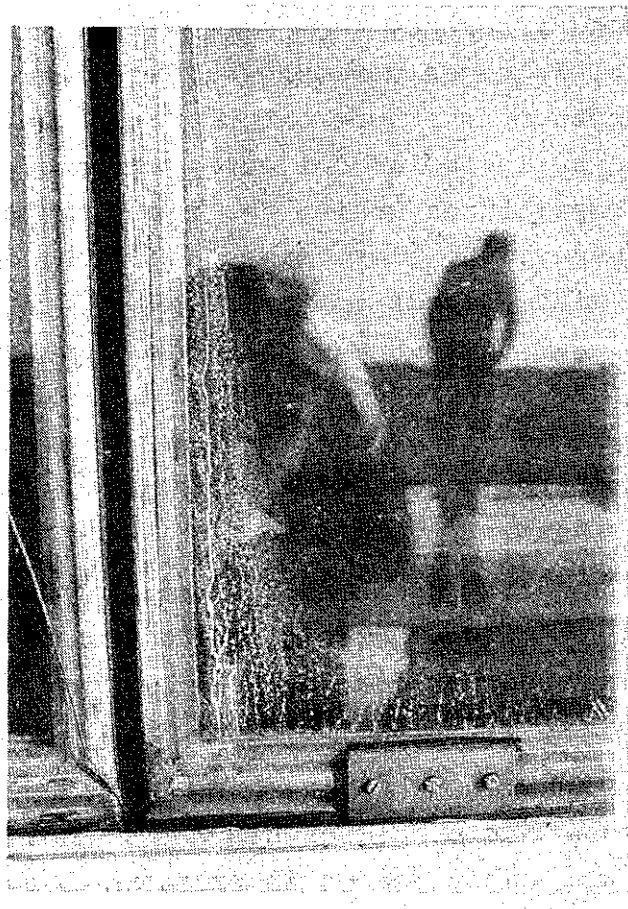
Fig. 2 Outgassing from insulation or from sealant.

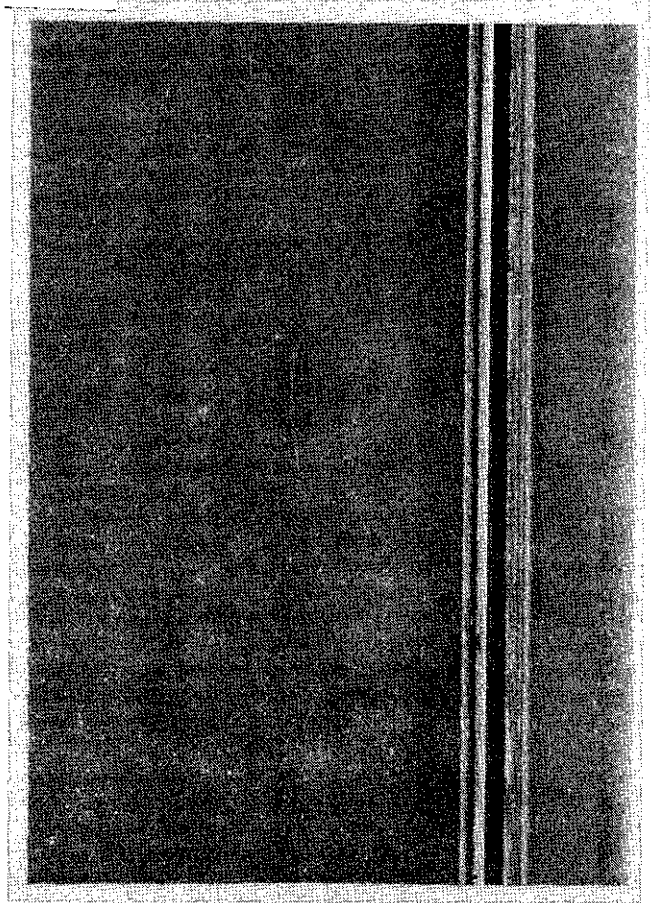
Fig. 4. Crack in glass probably beginning in the frame.

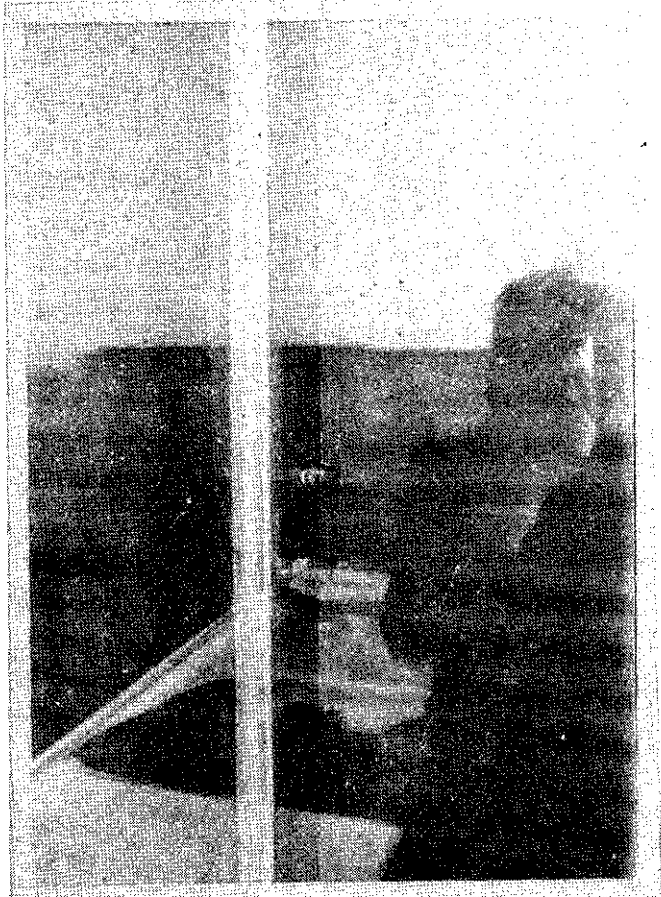
Fig. 5. Corrosion on attachment.

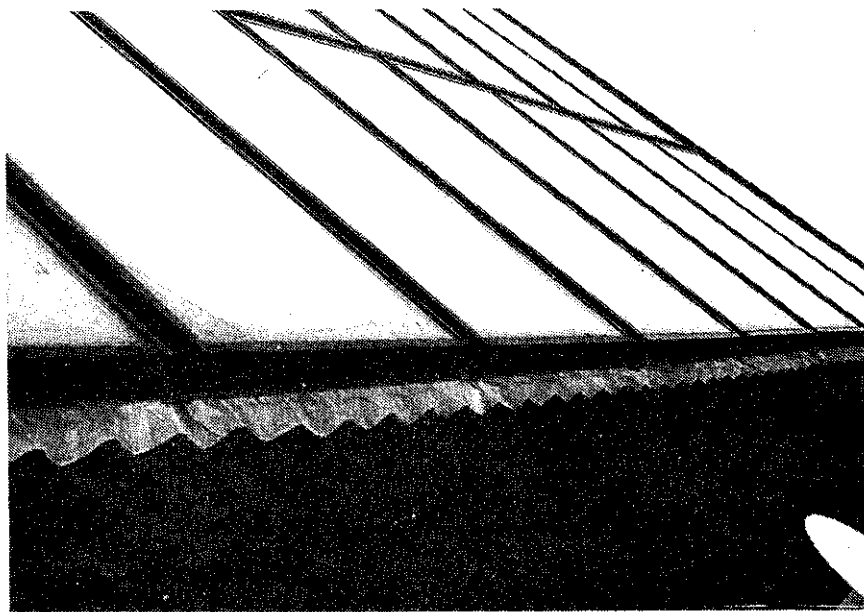
One of the covers broke during the repair of the collector leakage mentioned in item 4. (see fig. 2)

Fig. 2. One of the outer glass covers was broken in the corner.

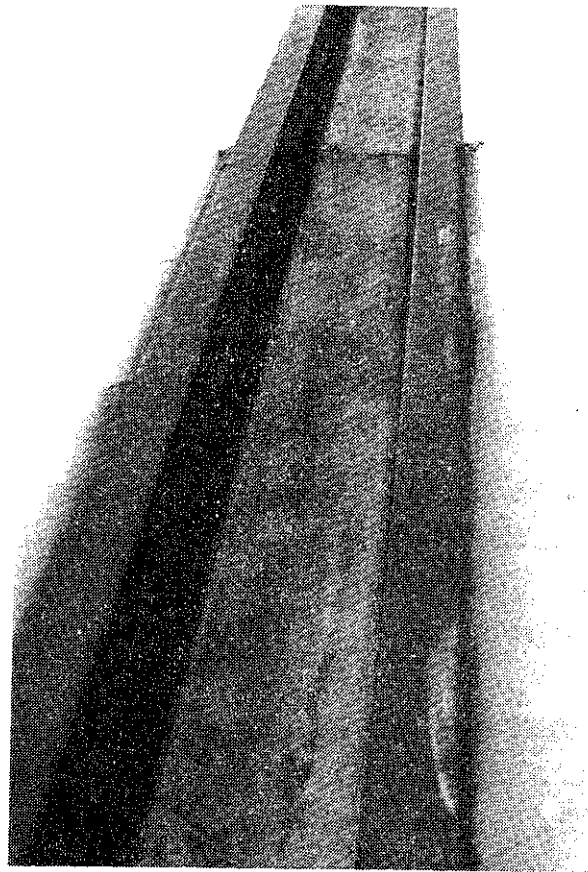
Fig. 5. Some of the silicone sealant are dissolved and parts of it are seen on different places of the glass cover.

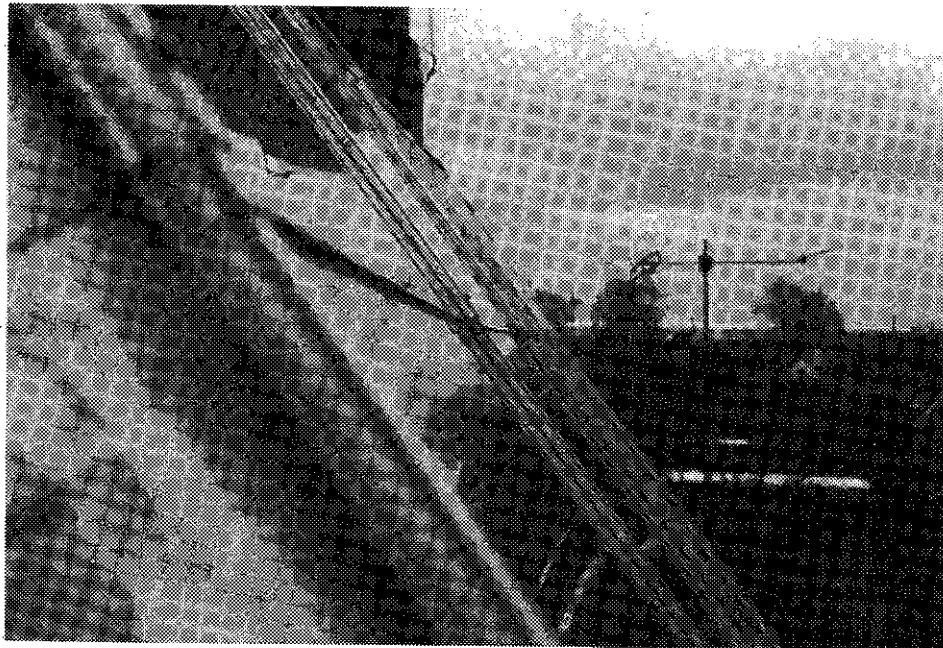
Fig. 4. The collector curved in the horizontal plane.

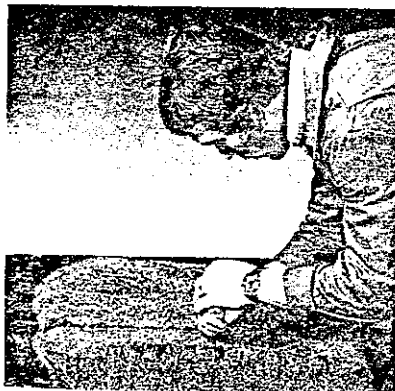
According to Danish circumstances this solar collector is quite an old construction. Ridge putty was recommended by the manufacturer for sealing in the bottom of the collector between absorber and glazing. There is no sign that the putty has been a bad sealing, but it has changed colour into dark brown and is certainly exposed to higher temperatures than it is supposed to be. At the present moment, it is difficult to say for how many years it will function satisfactorily.

Fig. 5. The ridge putty product used in the bottom of the collector.

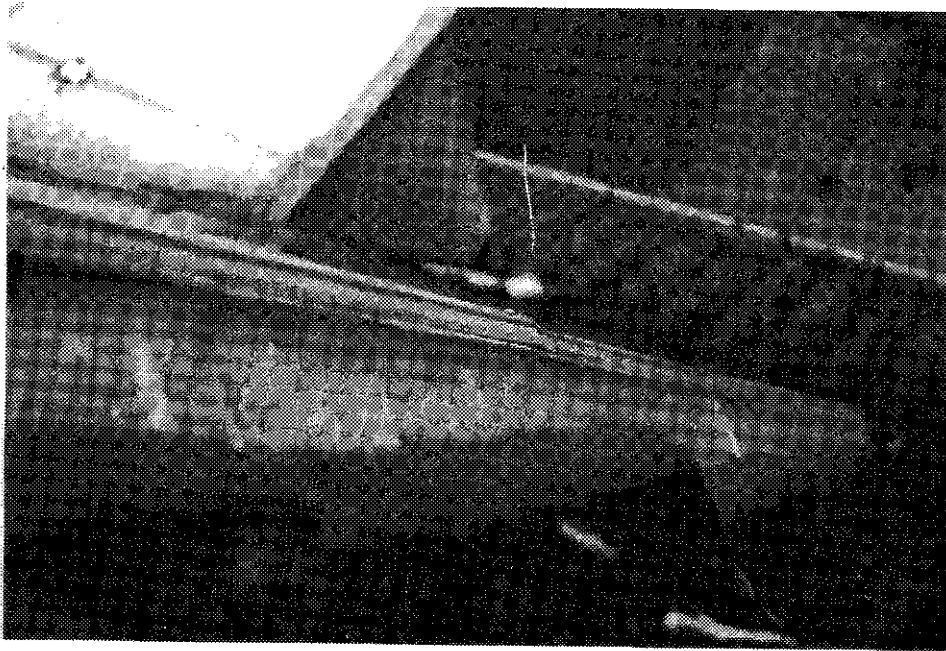
Flashband (a product to make valleys with) was chosen as flashing because it was cheaper than lead flashing. Lead flashing is generally recommended for this kind of collector constructions. In the beginning the collector was leaking rainwater into the house because of the flashband. The leaks were repaired with more flasband and a sealing material. At last it was raintight, and since then there have not been any problems.

Fig. 6. The flashing of the collector sides.

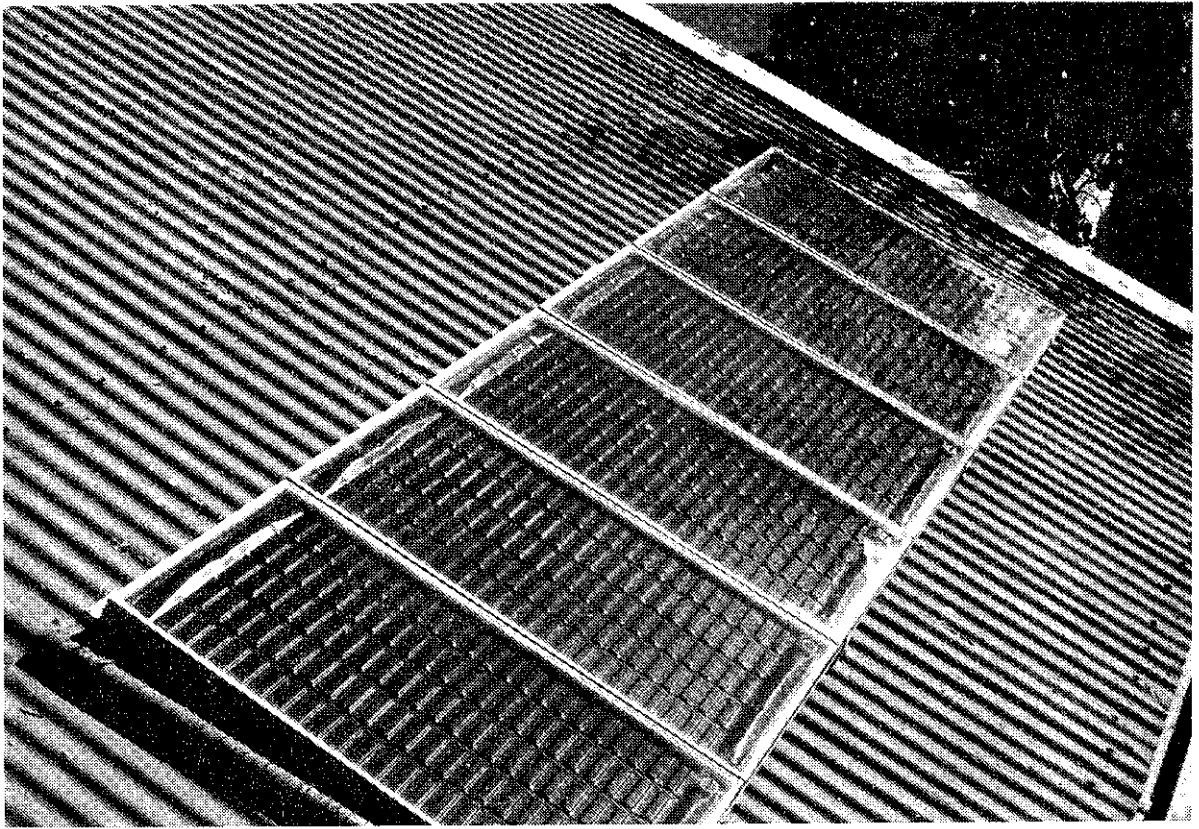
PHOTO 3B

1. Distortion of collector enclosure caused glass to separate from case. Subsequent leakage caused corrosion and condensation.
(Photo
