task III
performance testing
of solar collectors

subtask b
Development of test procedures for
reliability and durability

**FAILURE MODES
OF SOLAR COLLECTORS**

august 1981

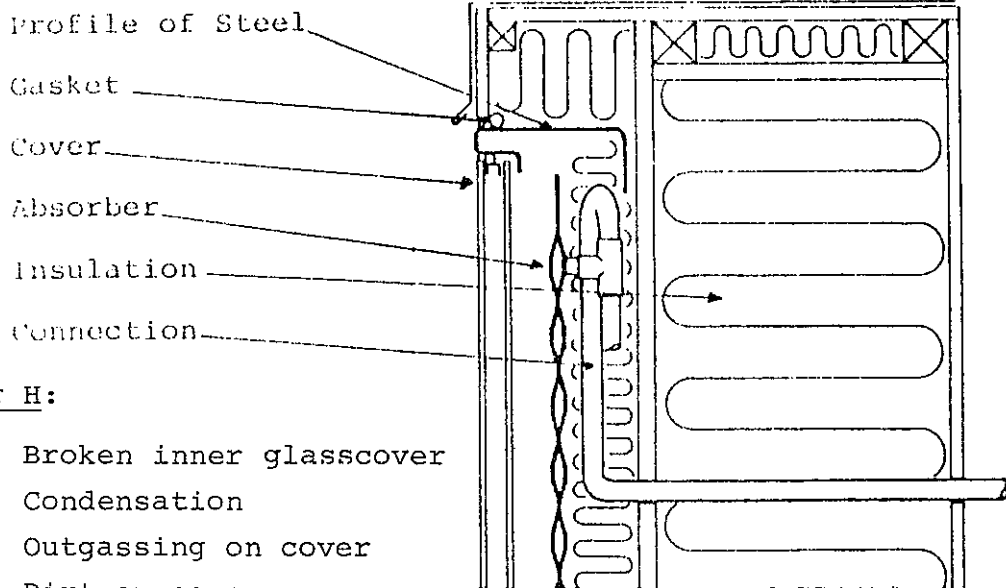
Collector H:

- 1-1-1 Broken inner glasscover
- 1-1-2 Condensation
- 1-2-1 Outgassing on cover
- 1-7-3 (L) Dirt on cover
- 8-3-2 (L) Corrosion of piping

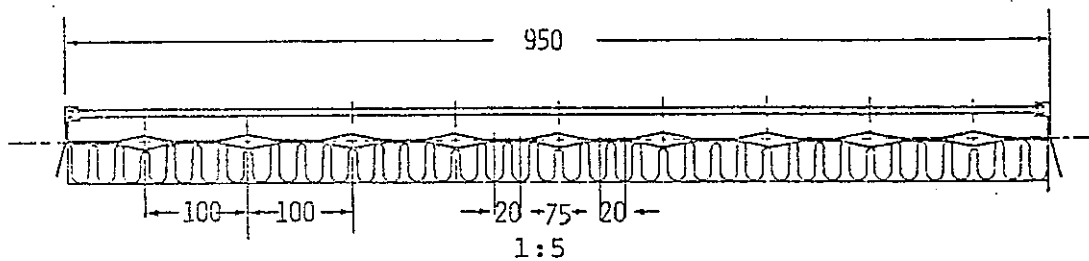
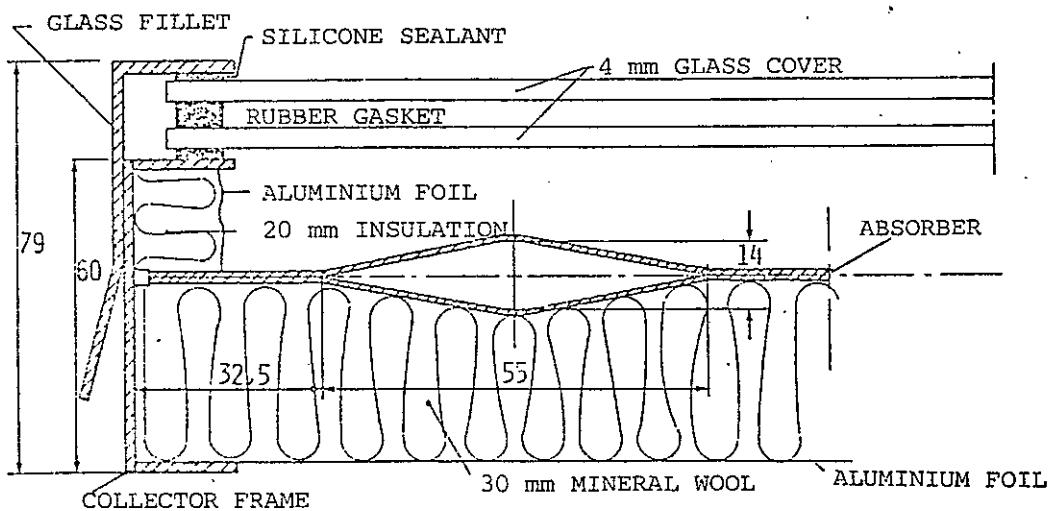
- Collector I:
- 1-1-2 Condensation
 - 1-7-3(L) Dirt on Covers
 - 2-2-3(L) Some silicone sealant dissolved.
 - 1-2-3 Cover spacing and insulation thickness too little
 - 5-1-2(L) Glassfillet causes rain leakage

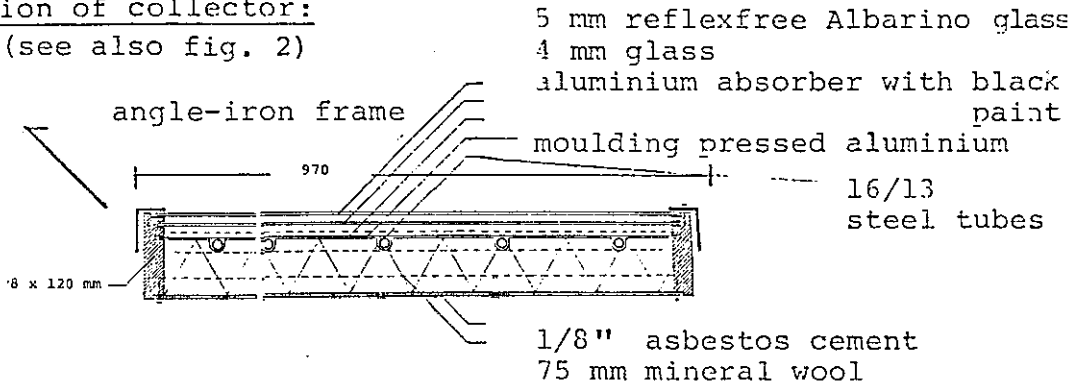
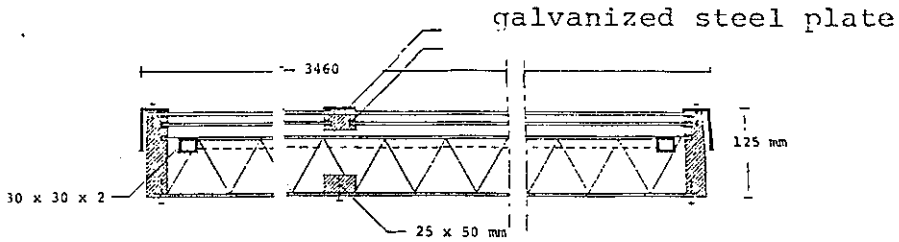
- Collector J: 1-7-3 (L) Dirt on covers
1-1-2 Condensation
1-2-1 (L) White deposit on covers
1-2-1 Outgassing on cover
3-2-1 Deposits on absorber
7-1-2 Flashing causes leakage
7-1-4 Repairing flashing is difficult

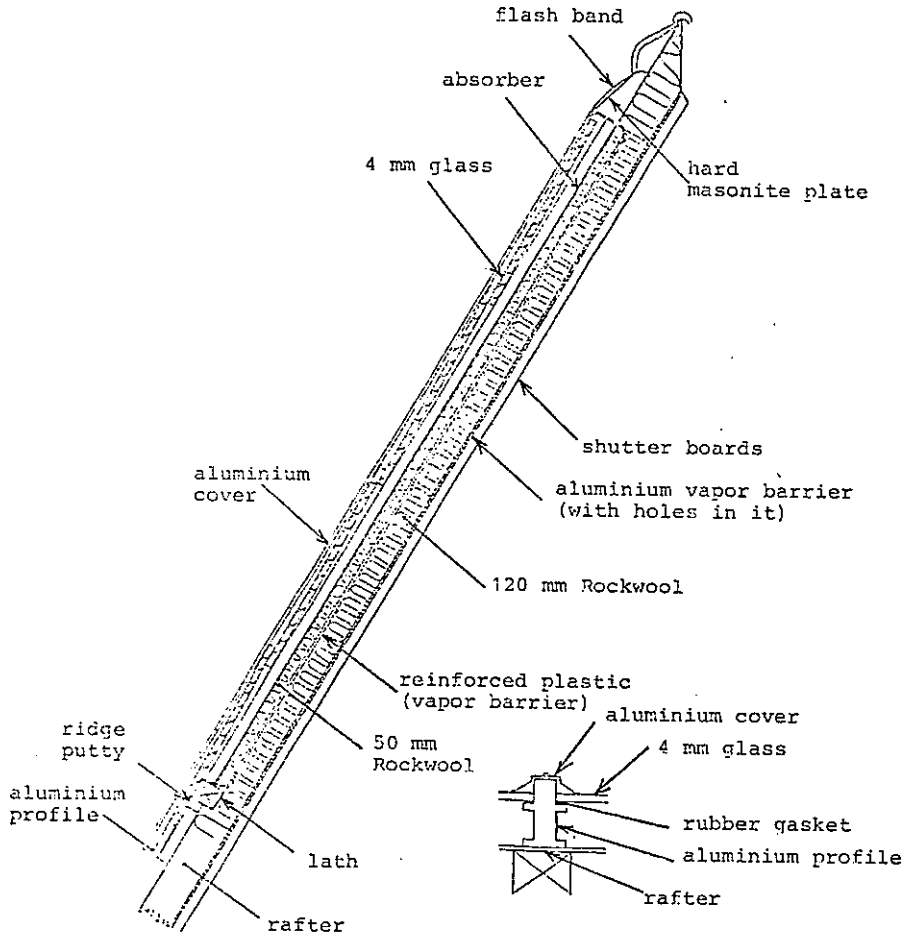
Fig. 1. CROSS SECTION OF THE SITE-BUILT SOLAR COLLECTOR IN VALBY.

<u>Collector K:</u>	1-7-3 (L)	Dirt on cover
	1-1-2	Condensation
	1-1-5	The cover curved and once a cover slipped
	1-3-5 (L)	Outgassing on absorber
	3-1-1 (L)	Dust on absorber

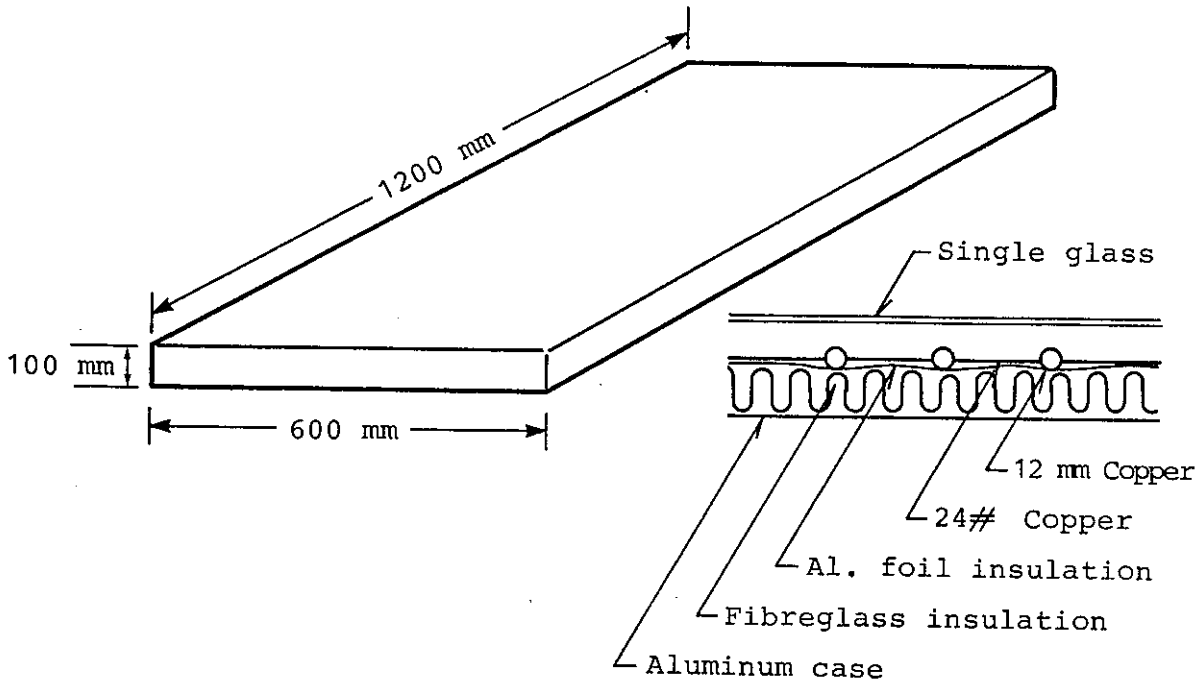
- Collector L: 1-6-1 (L) Glass discolouration (oversized)
5-1-3 (L) Sand accumulation (through ventholes)
5-3-2 (L) Interior case corrosion
8-4-2 (L) One junction of copper piping corrodes

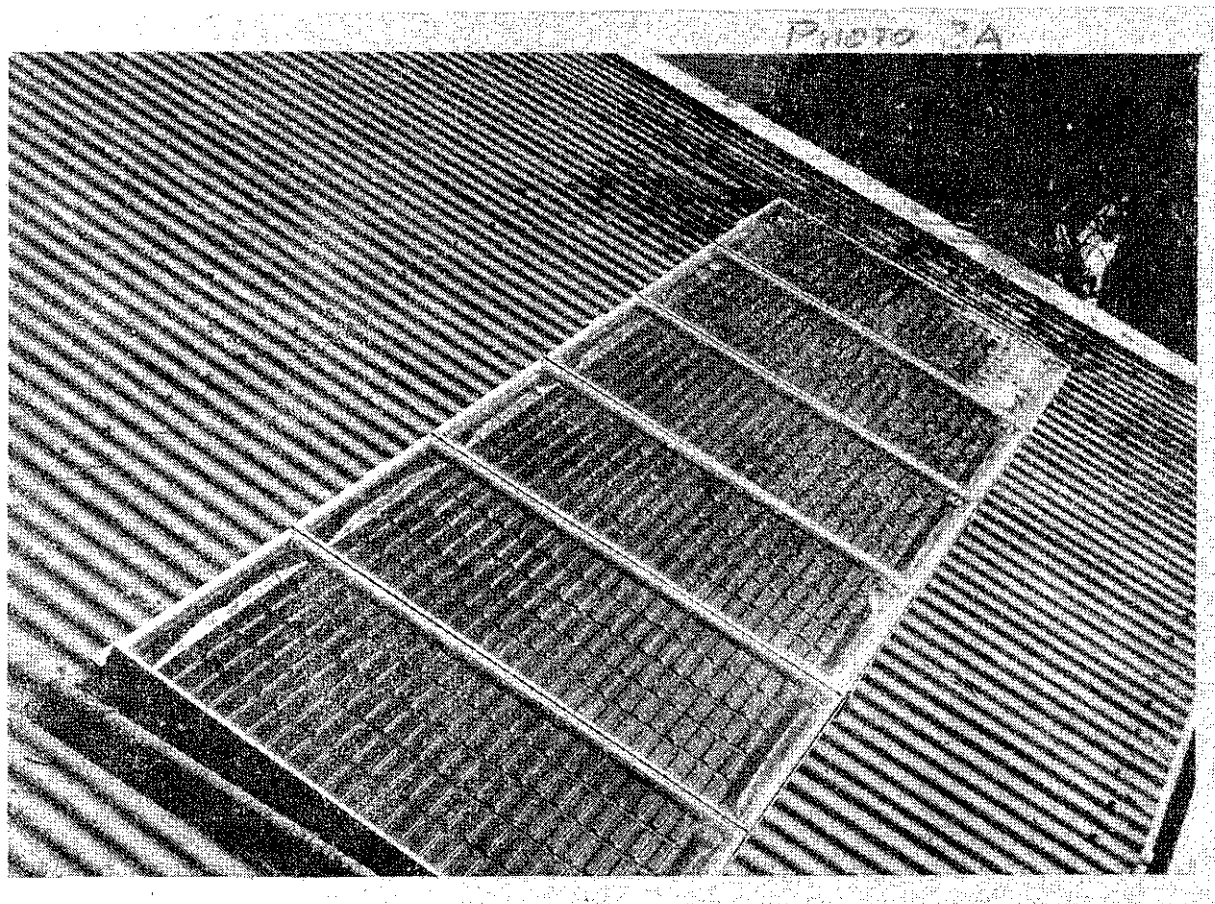
Collector N: 1-1-2 Condensation
2-1-1 Seal separated from enclosure because of:
5-2-1 Enclosure expanded
3-2-2(L) Absorber corroded

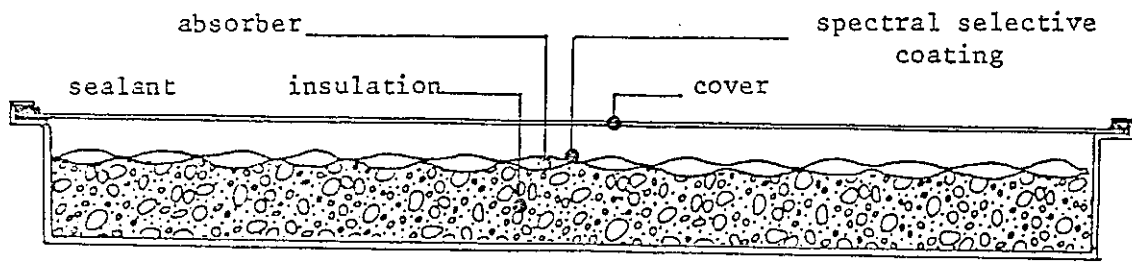
- Collector O: 1-1-2 Condensation
1-7-3(L) Dirt on covers
2-2-2 One collector leaked
3-3-5(L) One absorber leaked because of bad spot welding

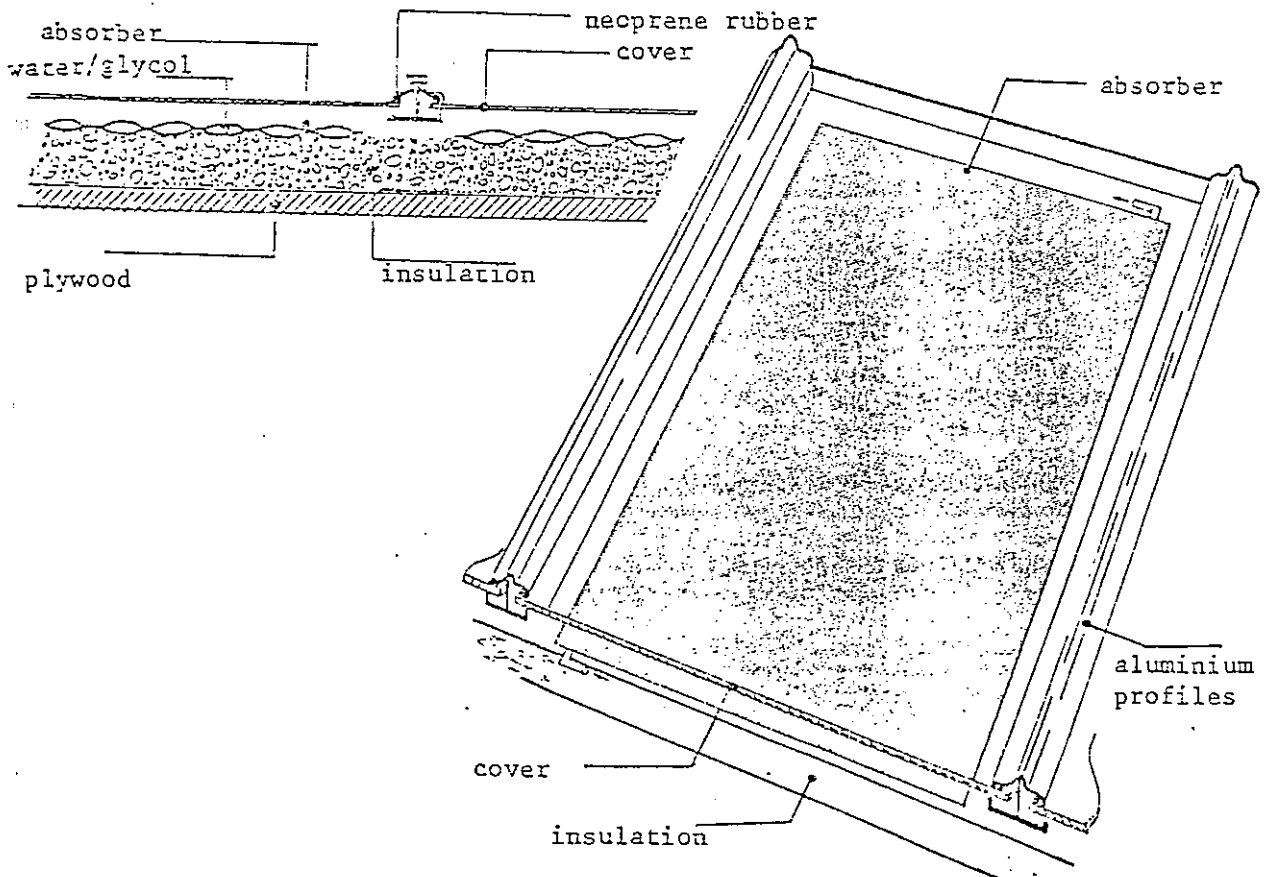
Collector P:

- 1-1-2 Condensation
4-2-1 Glass-wool insulation bagged out (not pressed)
3-2-5 (L) Coating of corners of absorber cracked, leads to corrosion
3-2-2 (L) Sensor corroded

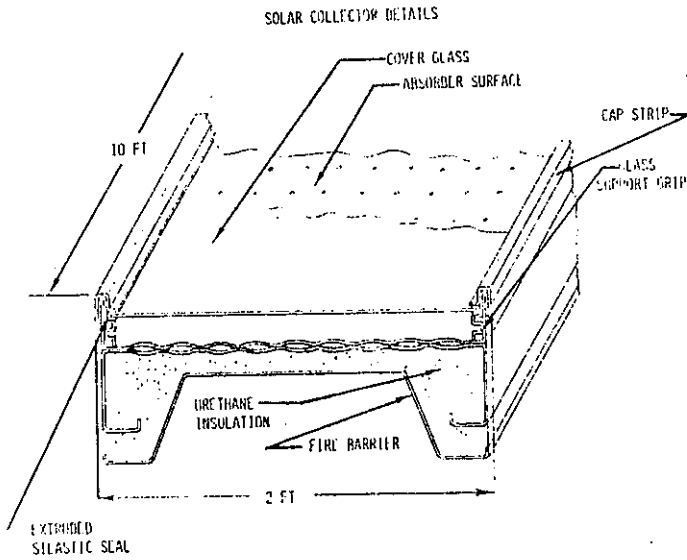
Collector S:

- 1-1-1 Condensation
- 1-7-3(L) Dirt on covers
- 3-1-3(L) Dirt on absorber
- 7-3-5 Paint flaking of flashing
- 7-1-2 Leakage through flashing
- 8-3-2 Leakage of piping system

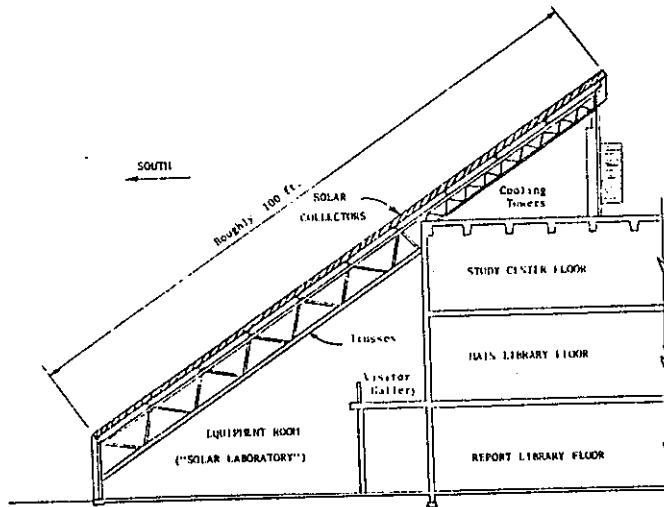
CROSS SECTION, NSR STUDY CENTER, LIS ALABIS SCIENTIFIC LABORATORY

Collector T1: 1-1-2 Condensation
1-7-3(L) Dirt, salt and sand on covers
2-1-1 Sealant failed
4-2-1 Warpage of sideinsulation
5-1-1 Enclosure warpage

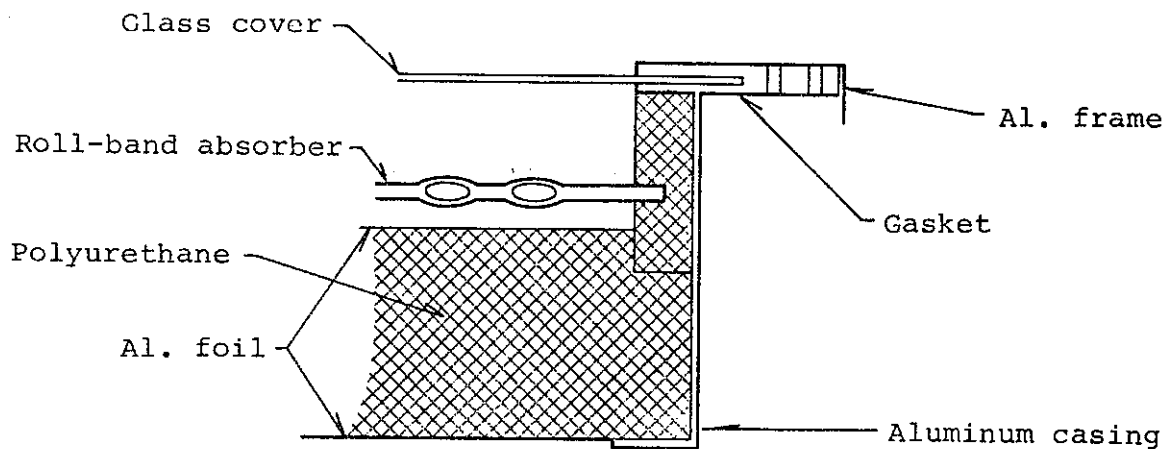
- Collector U:
- 1-1-2 Condensation (all collectors)
 - 3-2-2(L) Corrosion of absorber
 - 3-1-5 Temperature sensor loosened
 - 3-2-5(L) Carbonic deposition in heat exchanger

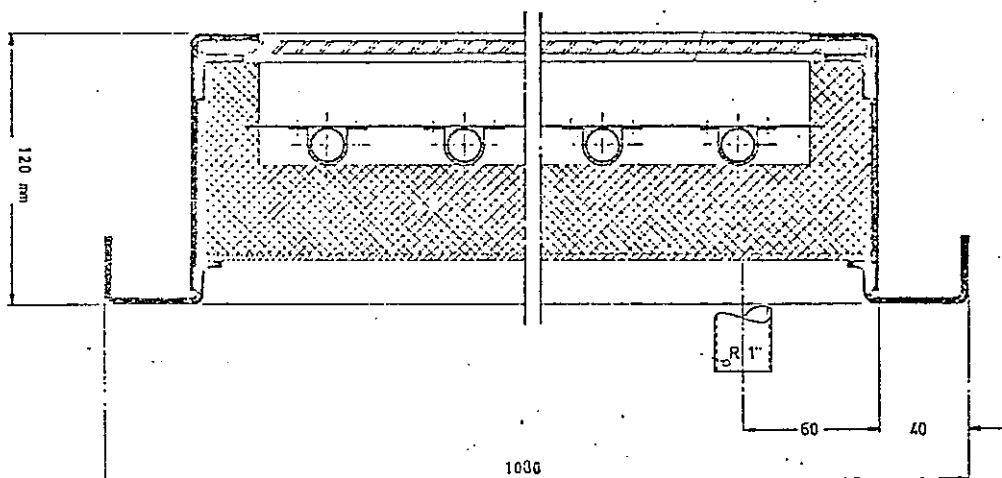
- Collector V:
- 1-1-2 Condensation
 - 1-7-3(L) Dirt on covers
 - 1-2-3(L) Cover degraded by insolation from sun
 - 3-1-2(L) Absorber with grey - white patches

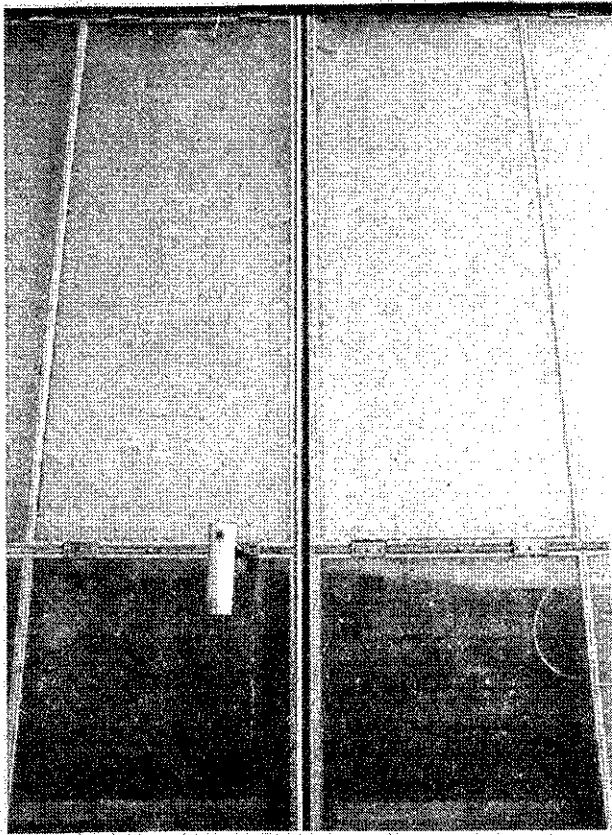
Four out of 32 panes were broken, and pieces had fallen down inside. Another five were only cracked, only inner panes. Fig. 3 and 4. The solar collector was exposed to stagnation at high temperatures during the installation period which was very sunny. The thermopanes used were designed in different ways with respect to ventilation of the airspace. It was strange to see that it was only the ones with modifications which cracked. The reason for cracking of the inner panes is the temperature difference between the middle and the edge of the pane. The edges of the inner pane function here as a "heat bridge".

Fig. 3. Breakage of glass-pane

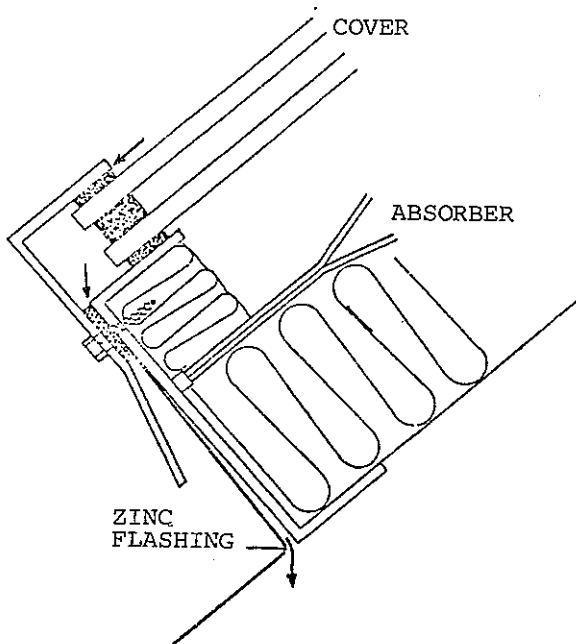
Fig. 3.

At first rain entered the collectors through the silicone sealant between the glass and the steel glass fillet at the bottom of the collectors.

The silicone sealant between the glass cover and the edge of the steel glass fillet at the bottom of the collectors was found not to be raintight after a period of operation, as shown in fig. 3. This was the reason for rain leakage into the collectors and from the collectors into the house when it was raining. The best solution to this problem could be a different collector construction where the upper glass cover would have no steel frame at the bottom of the collector so that water could run off the collector. In Greve the collectors were repaired by introducing an extra zinc flashing into the collector, as shown in fig. 3 and 4. This seems to be

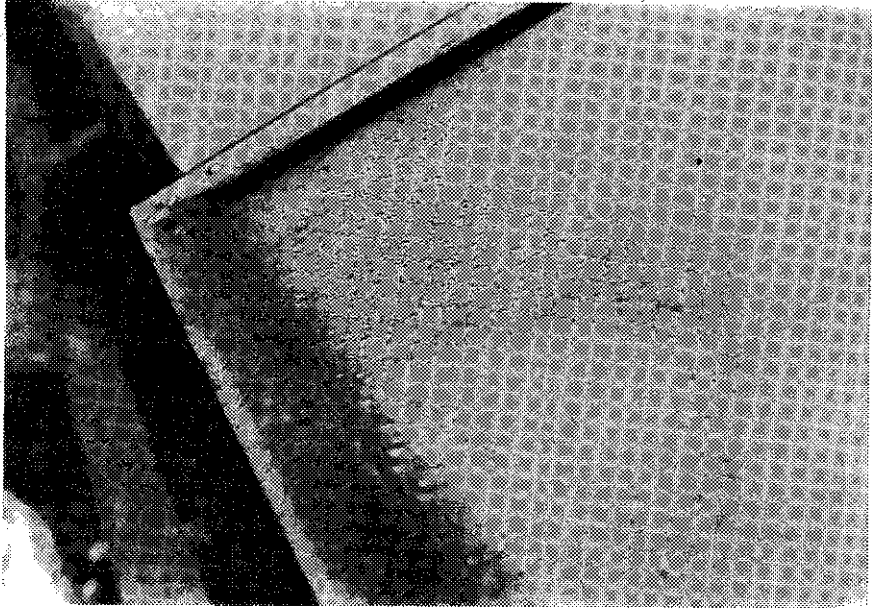
Nearly all of the solar collectors had condensation on the inside of the outer glass cover. About half of the collector area was with condensation. Big drops which could drip at the lower glass cover were seen (see fig. 3 and 4).

Fig. 3. Condensation in a collector of the same type which is used in Gentofte.

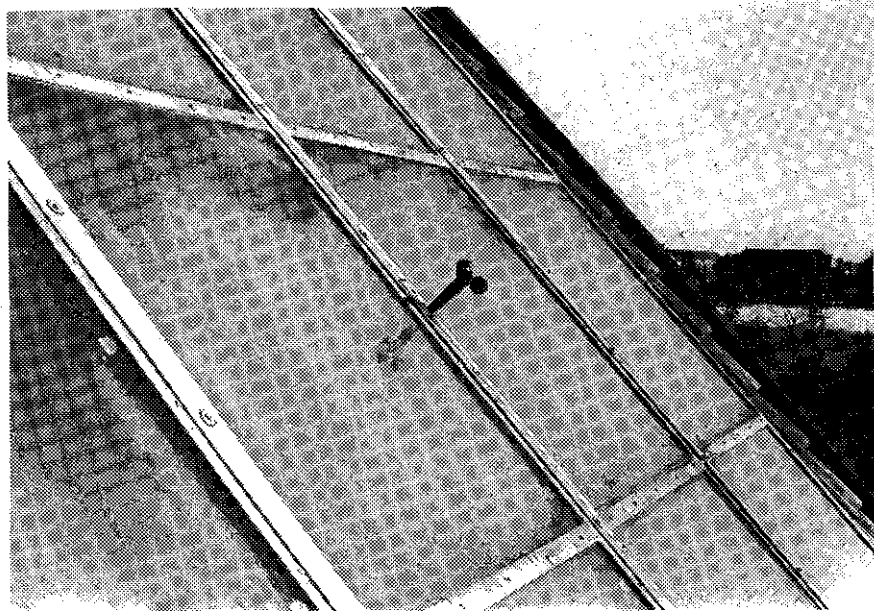
Fig. 4. Solar collectors with condensation.

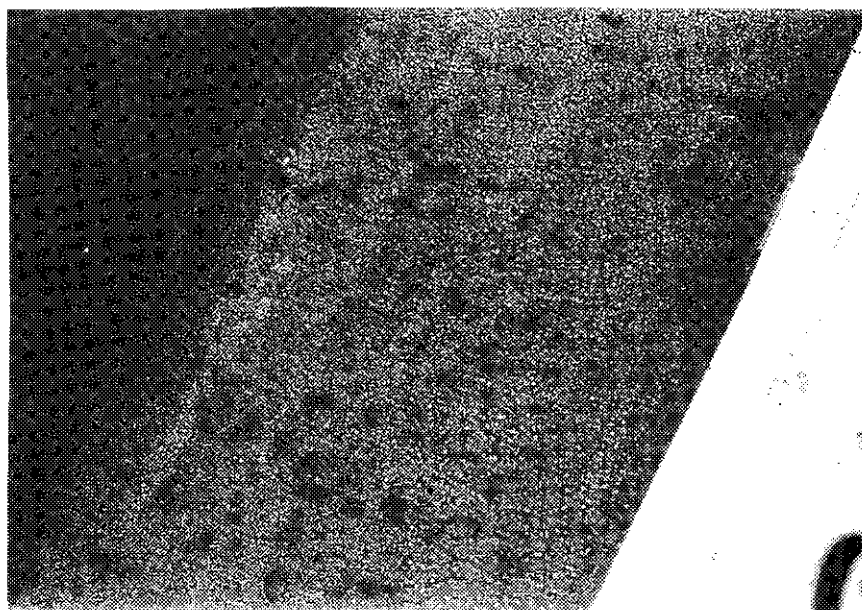
There was also a lot of corny white deposit on large areas of the outer glass cover (see fig. 5).

Fig. 5. Example of white deposit on the inside of the outer glass cover.

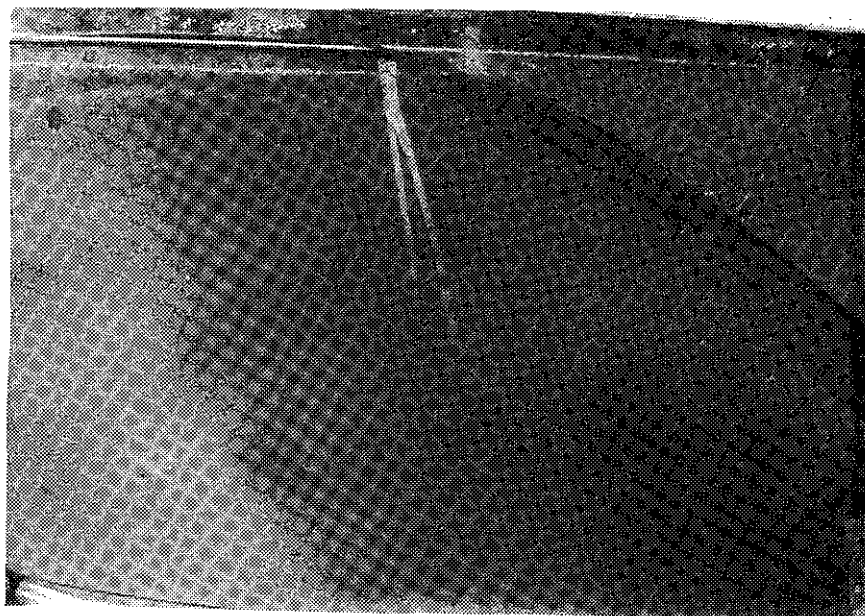
A few brown sticky looking small deposits were observed on the absorber plate, which we also think was resin from the wood frame (see fig. 6). It was observed during the summer period that resin fluid was produced in the wood when there were high temperatures in the collector.

Three of the outer cover glasses were broken because of careless treatment of the collectors. The last time was when the contractor tried to solve the leakage problem through the flashing. It was very costly to repair the collectors because you have to remove all the collector flashing and lift the collector modules up just to change one glass cover. This is a good example of bad maintenance facilities of solar collectors.

Fig. 6. Brown deposit on the absorber surface, and example of the outer glass cover which broke and was very expensive to change.

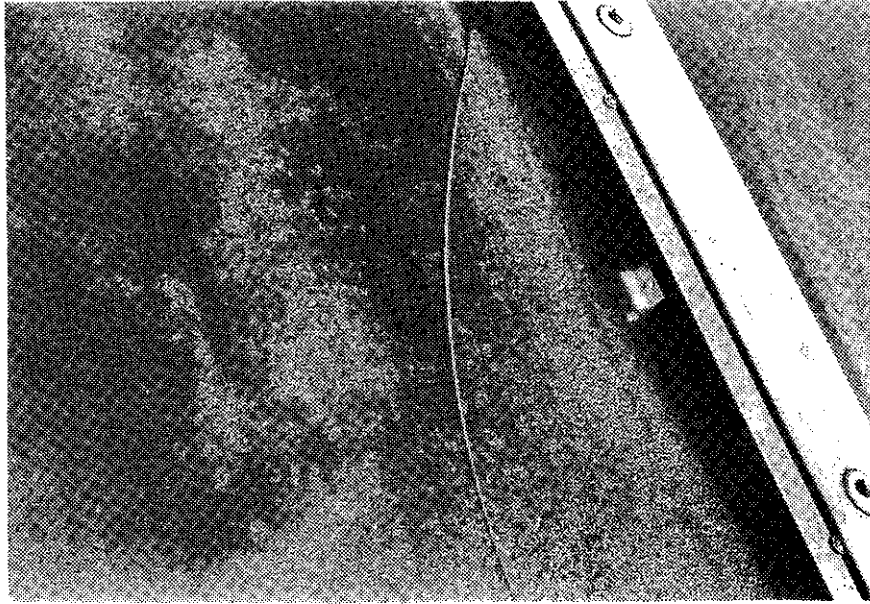
There have been some minor rain leakages in the collector construction. The problem has been localized to the galvanized steel plate flashing. In fig. 7 you can see what we think might be the reason. The steel flashing rests on some screw heads of the collector. The installation contractor has now tried to improve the flashing, so now it should be rain tight.

Fig. 7. Here you can see the galvanized steel plate flashing which rests on screw heads of the collector.

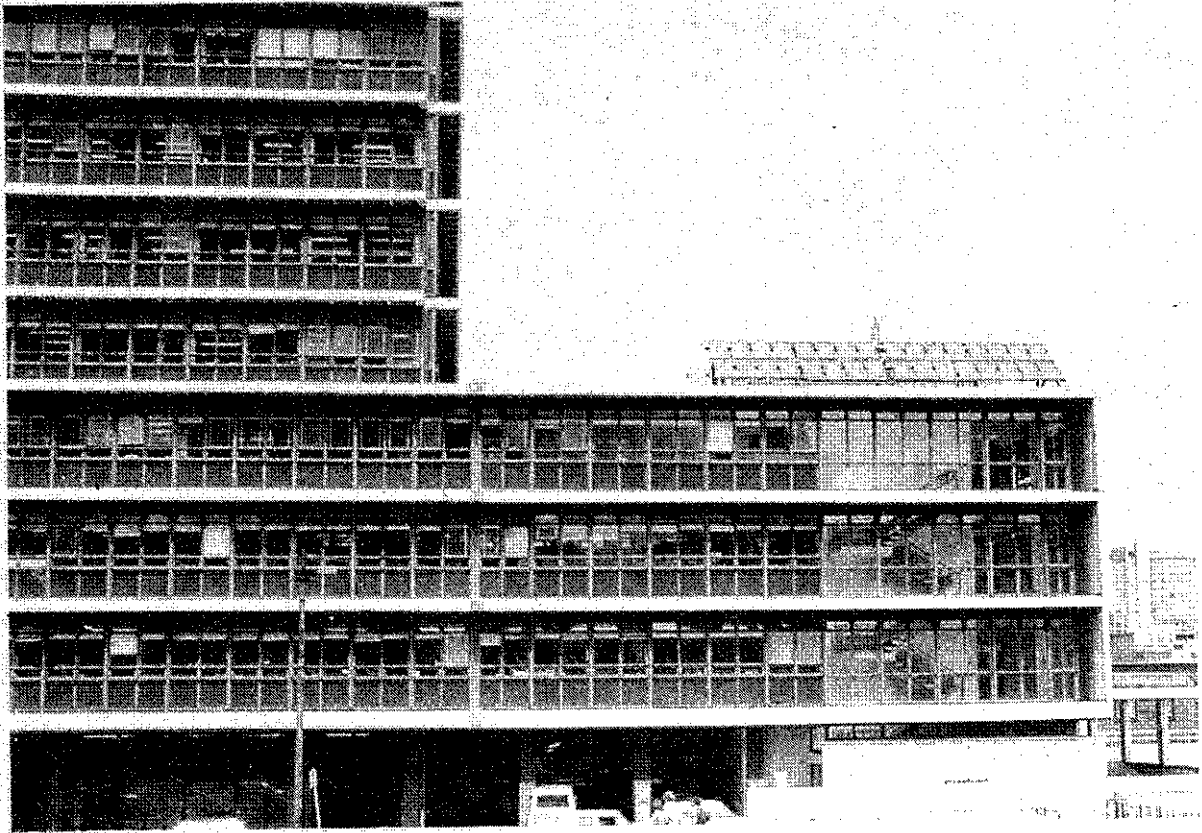
Photo 1A

This system is oversized for summer use, and on sunny days the water in the collectors boils and is released through the pressure relief valves shown in the photo. Boiling water rains down on the collectors nearby and has (over 3 years) produced a brown coating on the glass. Other collectors are clean (rain). Glass can probably be cleaned by scouring. Only 8 collectors affected.

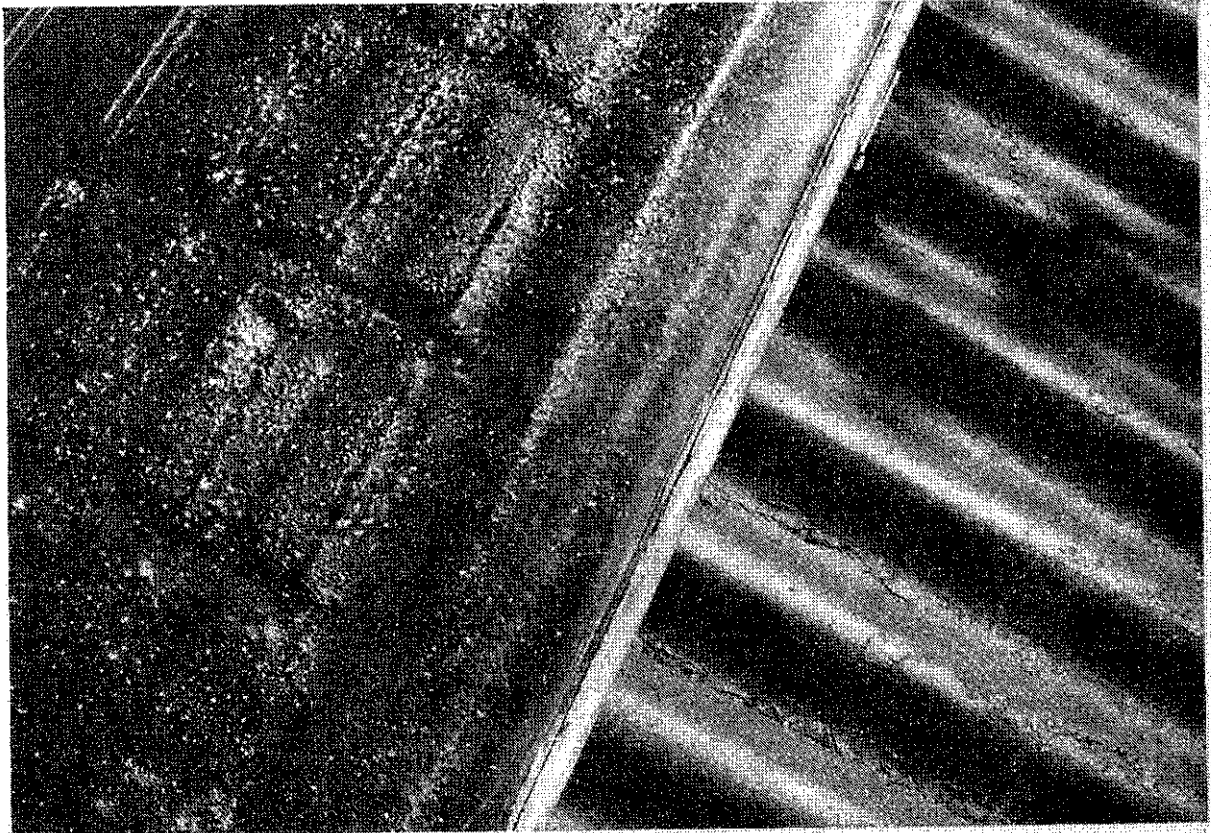
PHOTO 3B

1. Distortion of collector enclosure caused glass to separate from case. Subsequent leakage caused corrosion and condensation.
(Photo

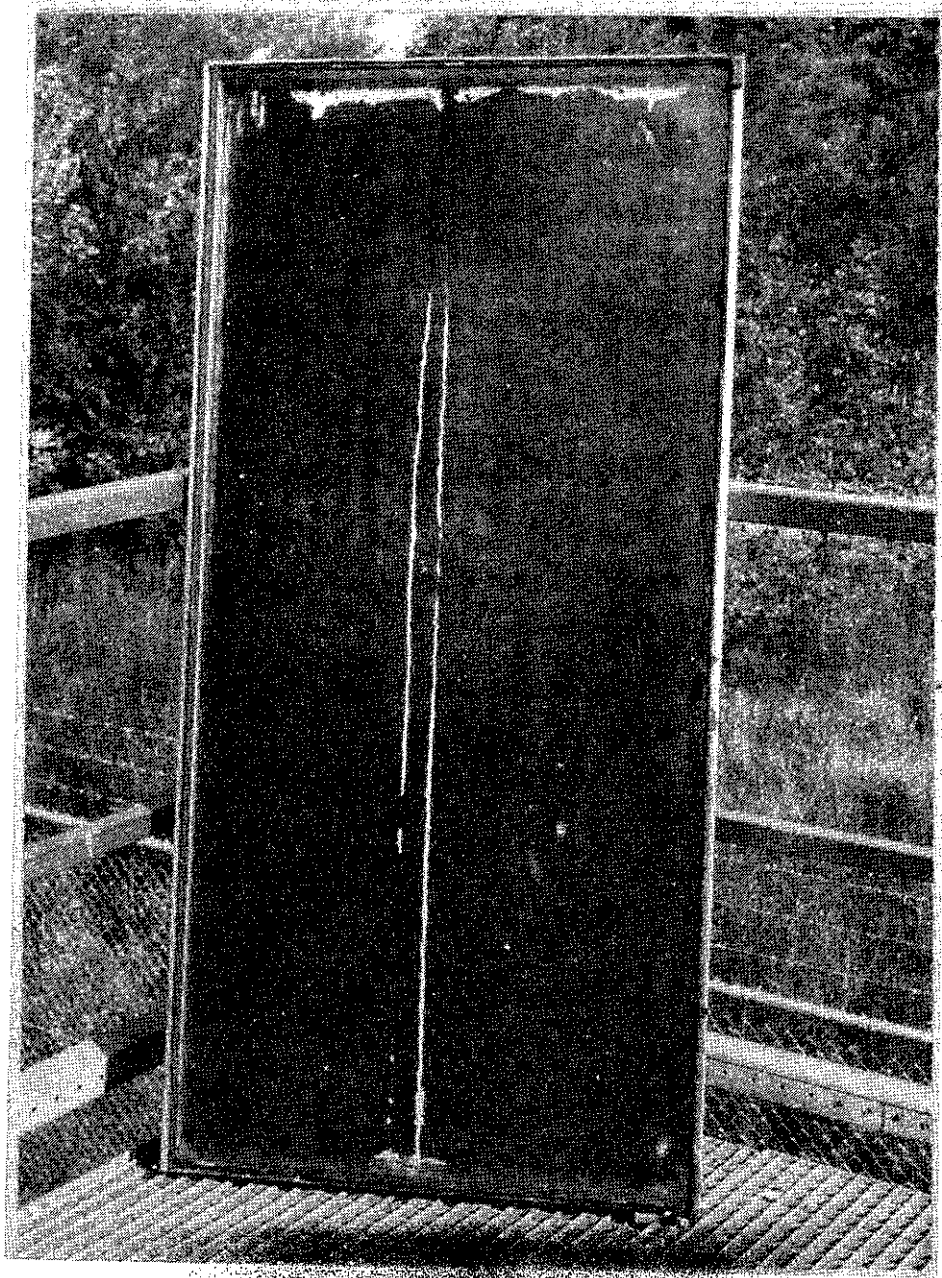
1. In the early morning condensation may occur on the inside of the glass cover, due to the low temperature of this pane and because it is ventilated with ambient air.
This condensation caused a slight weathering of the inside surface of the pane.

2. During the three years' period the panes have not been cleaned. It seems that there is a stabilisation of dirt after a few months, only near the corners and the edges some extra dirt is observed.

3. In one of the 90 collectors there has been a leakage of rain. This was caused by a bad sealing between the cover and the enclosure.
Remedy: more attention to the fitting of the sealants.

4. Due to uncareful handling during transport and mounting, the coat of enamel on some corners near the connections was cracked, followed by corrosion.

5. In one collector a small leakage was observed, probably caused by a bad spot in the weld (see picture 1).
6. After three years the mixture of water and glycol had to be changed, as indicated by the supplier of the glycol.
The new glycol was of a non-poisonous type.

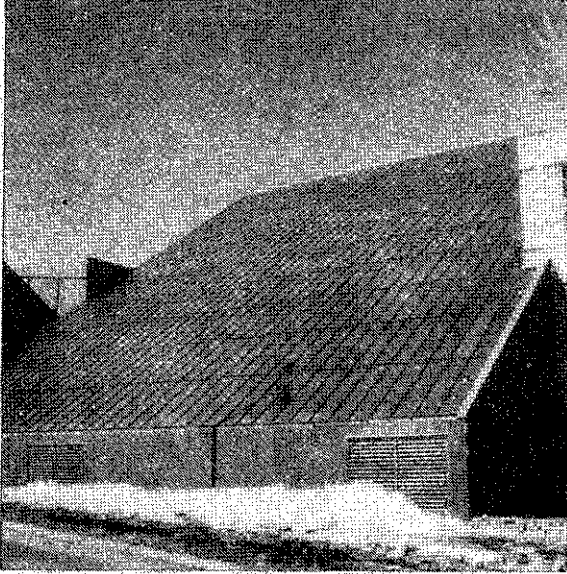
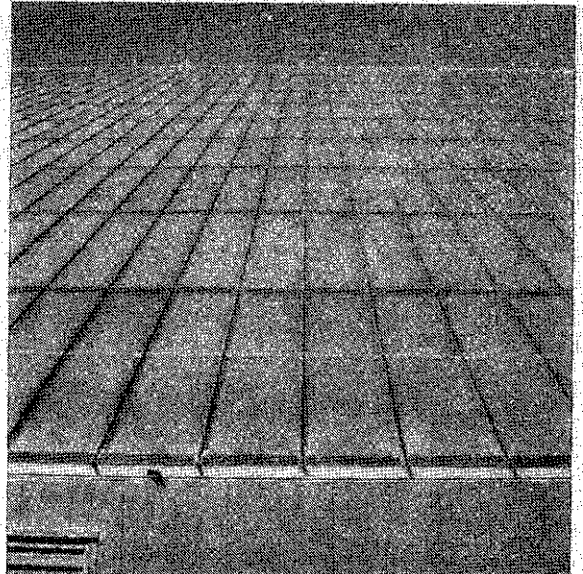
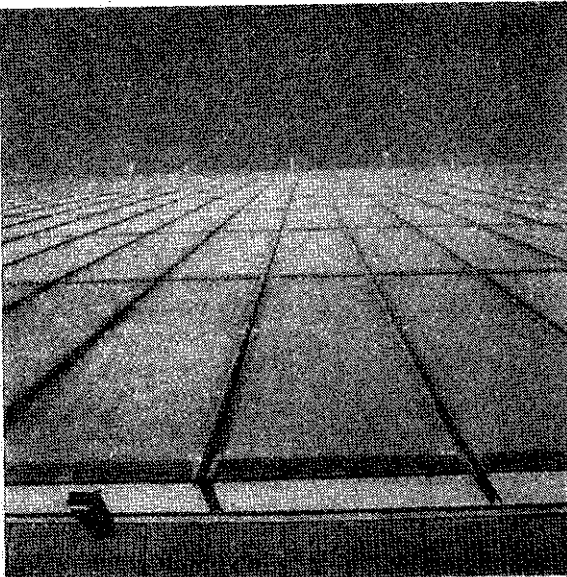
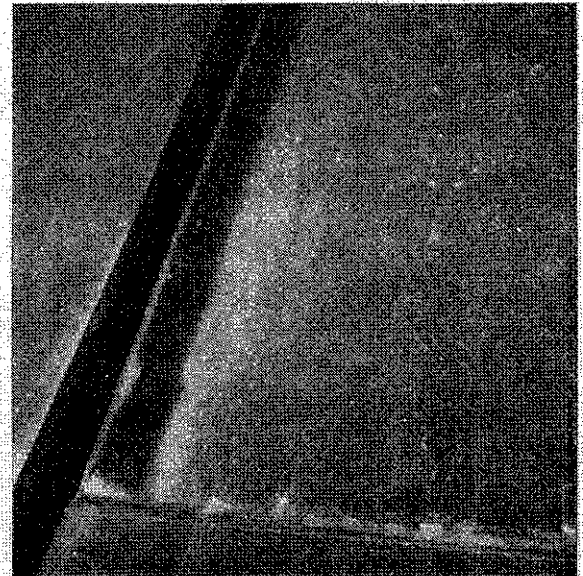
Some rain leakage occurs at a few points during periods of heavy rain. They have occurred during initial construction and have never been investigated or a repair attempted.

There are approximately 12 points where minor leakage of the paraffinic oil leaks from piping system which attaches the collectors to the header system. Each collector, 404 total, has 16 joints of potential leakage which attaches it to the header. The maximum leakage is approximately 1/2 teaspoon/day from any of the leaks. This is not felt to be severe enough to warrant repair. All of these leaks appear to be coming from pipe fitting joints. All other leaks detected during initial leak tests or initial shakedown consisting of split elbows, cross threaded ferrules, joints not adequately tightened, etc., have been stopped.

Photos showing the collector array's external conditions are attached.

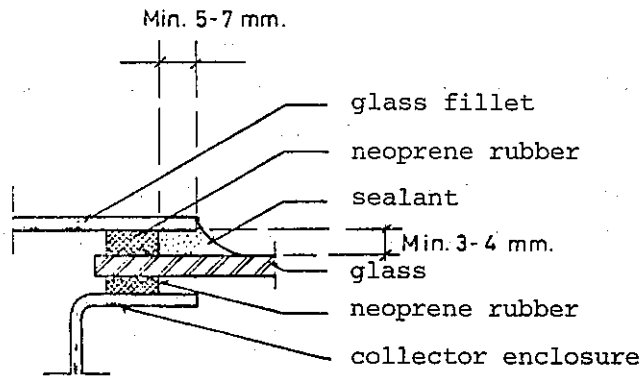
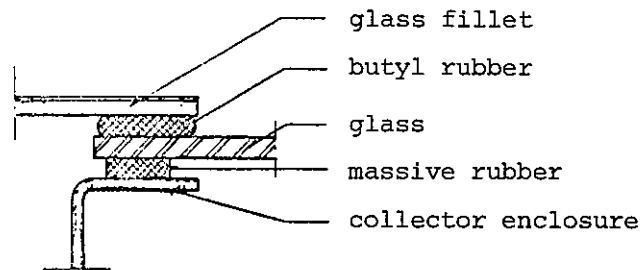
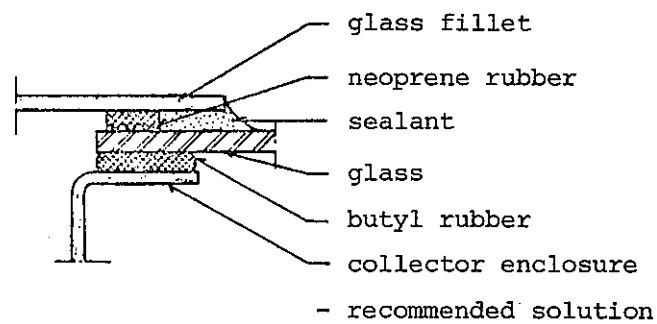
Fig. 1. Recommendations for cover/enclosure assembly - three solutions.

Fig. 1 and fig. 2 are examples of recommendations for respectively cover/enclosure assembly for solar collectors and installation of solar collectors, either as modules built into the roof or as site-built solar collectors.

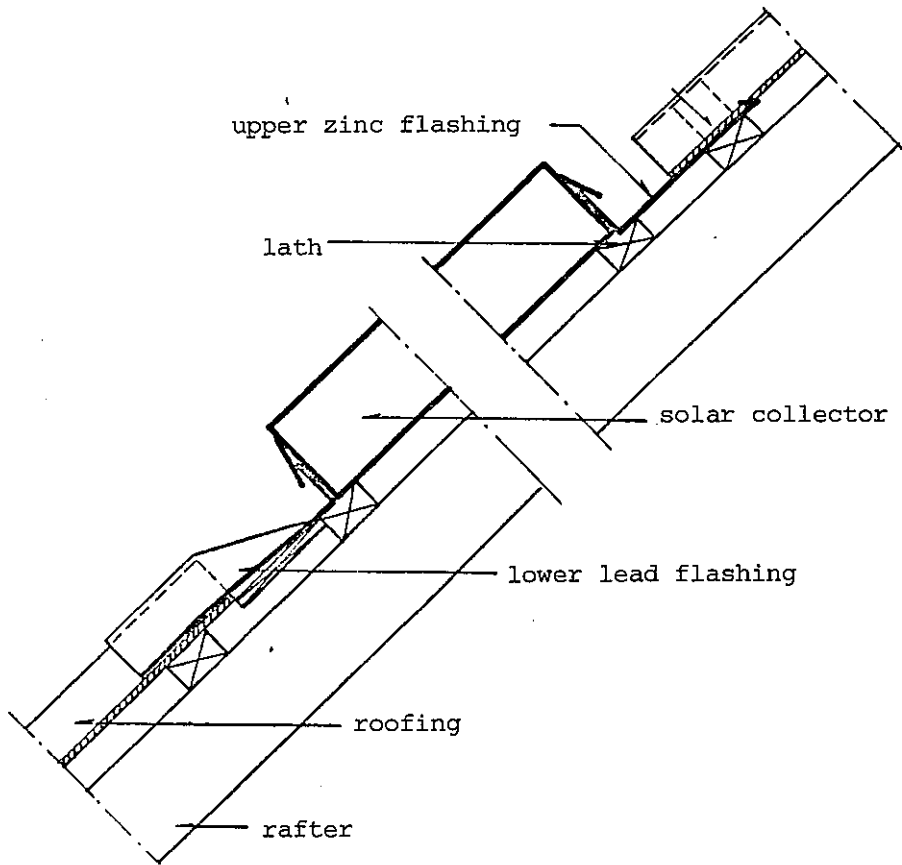
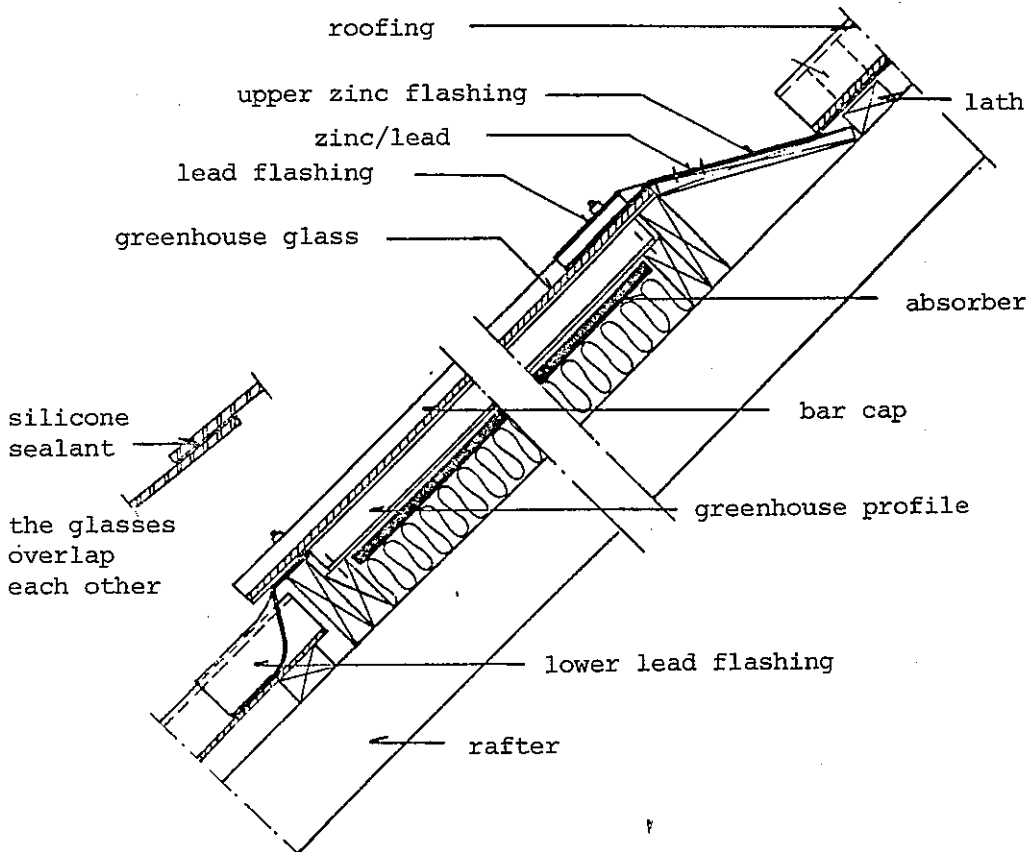
Fig. 2. Recommendations for installation of solar collectors.

Solar collector built into the roof

Site-built solar collector with a greenhouse type of glass cover
